## **OWNERS BEWARE – ENGINEERING OIL & GAS PIPELINE CROSSINGS AND THE DEVELOPING REQUIREMENTS OF THE CLIENT**

Paul Deslandes, Global Marine Group  
Email: [Paul.deslandes@globalmarine.co.uk](mailto:Paul.deslandes@globalmarine.co.uk)

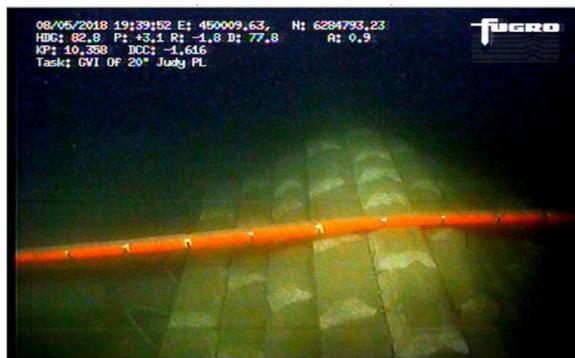
Whilst the methodology previously mentioned was the norm for Crossing Agreements, in cases where the pipeline was exposed on the seabed it became apparent that the fibre optic cable had suspensions either side of the pipeline, due to the minimum bending radius of the fibre optic. This approach inevitably led to potential risks for both asset owners.

Figure 1.1: Cable Suspension

The suspended cable meant that the risk of fishing equipment becoming entangled with the fibre optic cable was significantly increased, which also led to the potential of discarded fishing gear being left over the pipeline.

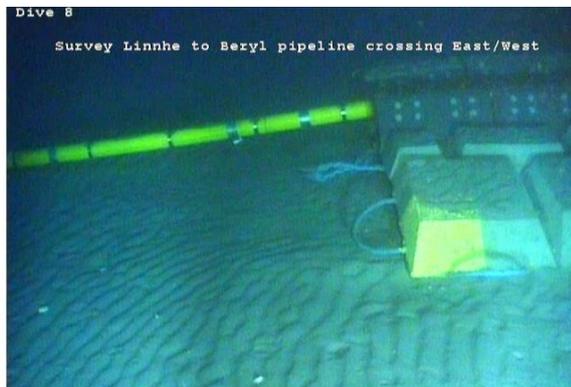
In cases where the pipeline was buried, then the 300mm requirement was a simple solution, as this was the depth of a mattress. This meant a 6m x 3m mattress could be placed directly over the crossing location in preparation for the fibre optic installation as shown in Figure 1.3.

**Figure 1.3: 300m Mattress (buried pipeline)**

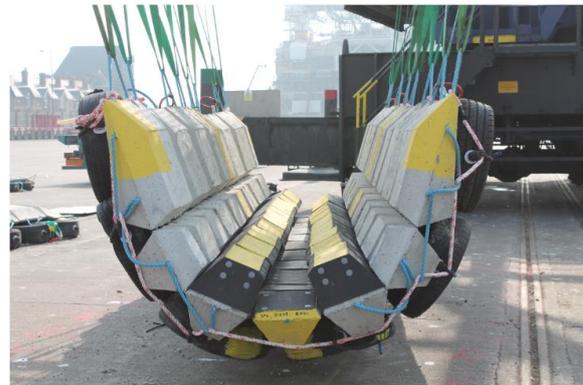
Where the 500mm separation was required a combination of the 300mm depth mattress and a layer of tyres was installed to reach the 500mm requirement. In order to make the deployment of the 500mm mattress more practical, the tyres were connected to the mattress prior to deployment so that only one operation was required to get the tyres and mattress deployed in situation.

**Figure 1.4: 500m Mattress**

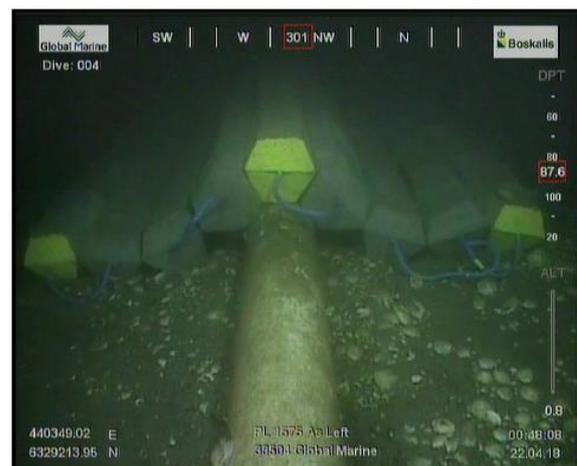
Where the pipeline was surface laid or partially buried, the same solutions mentioned above were utilised based upon separation requirements.

**Figure 1.5: 300m Mattress (exposed pipeline)**
